Presentation to Team Florida

Critical Issues in Occupancy
Enforcement and the I-15 ML Test

May 12, 2011

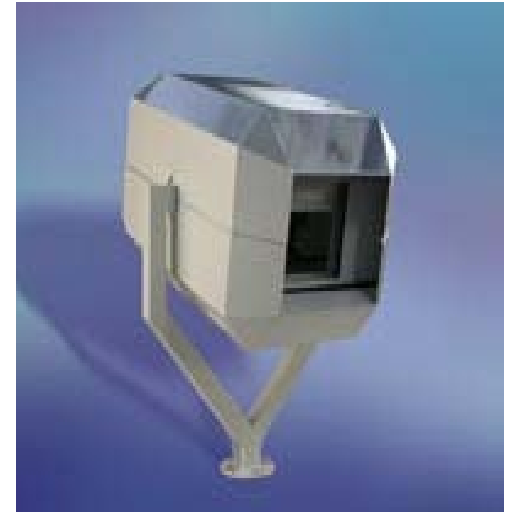
Vehicle Occupancy Camera

- Lane based camera system
- Aimed at interior of vehicle
- Infrared wavelength based
- Images of occupants obscured to avoid privacy issues
- Ties an image to an occupancy record

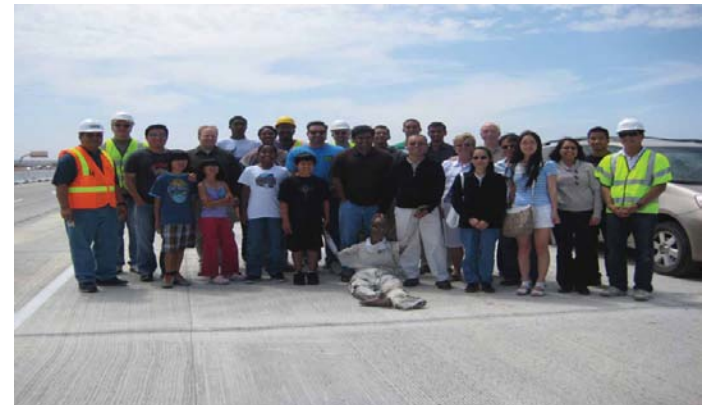
SANDAG VOL Occupancy Camera Test Summer 2010

- FHWA VPP based project for Violation Enforcement
- RFP in 2009 for testing on I-15 ML
- Delcan System Integrator with Vehicle Occupancy Limited (VOL) camera selected
- Controlled tests took place weekend of July 30, 2010
- Test Team: Delcan, SANDAG, HNTB, PATH/CCIT SMG, Caltrans and CHP and volunteers

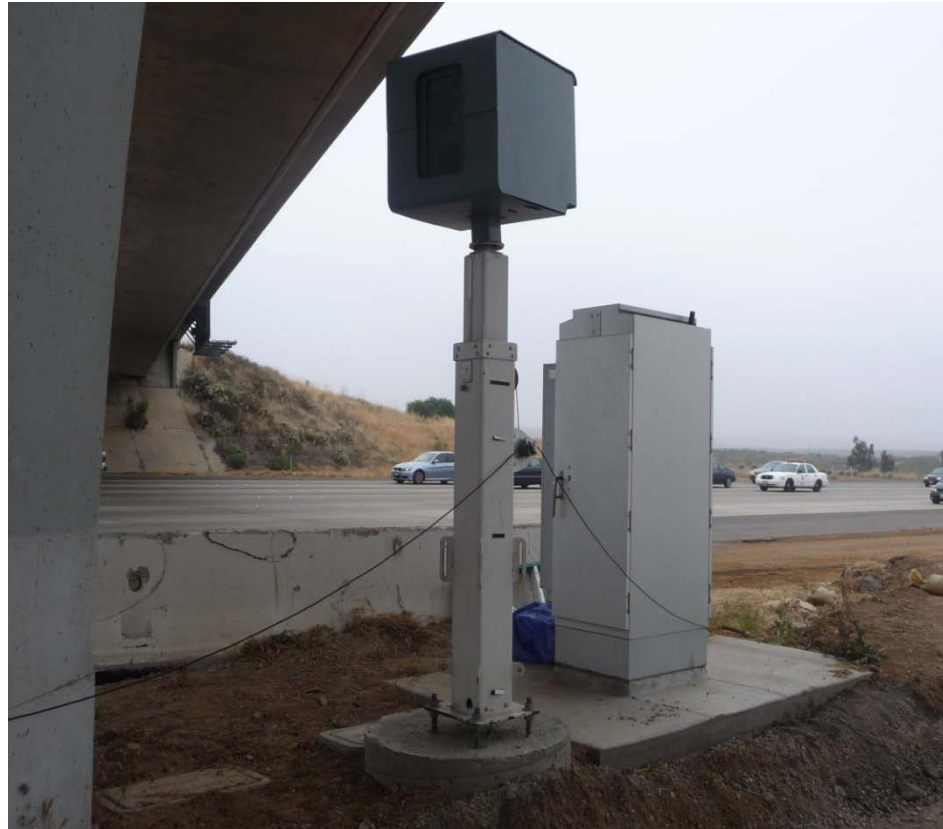
Miramar Way Test Site Equipment Close-up

- External trigger signal detects presence of vehicle.
- Camera then illuminates the windshield area with two different wavelengths of infrared light.
- Two digital infrared pictures are taken of the windshield at the instant of illumination.
- Near real time processing of images through VOL's algorithm
- Record created with number of occupants
- The system obscures the images of occupants in the vehicle by placing a green blob over their faces.

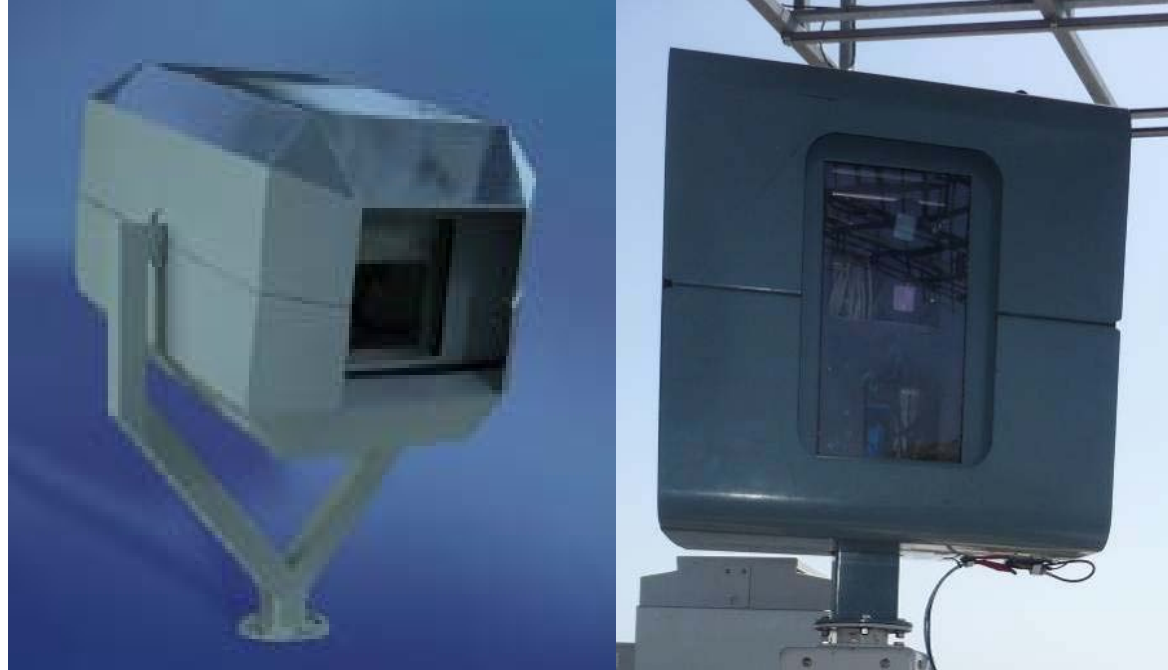
Planned P90 Versus Working Prototype P30

- Adapting P30 to 12 foot lane expanded field of view was not adequate
- Lack of precise trigger control
- Power density of the infrared lasers needed to be doubled
- Camera exposure reduced to capture higher speed vehicles impacted image quality/timing
- System did not deal well with partial faces
- Detected areas outside of region of interest
- VOL post processing

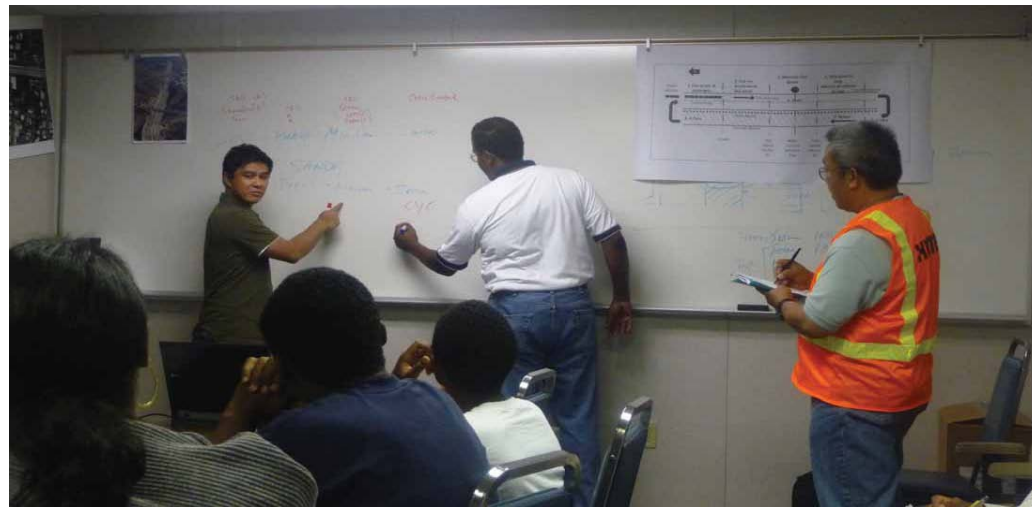
Summary of Testing:

- 552 controlled test points/runs
- Focus on all possible scenarios
- 48 Semi-Controlled Runs
- Multiple days data available from uncontrolled testing

Controlled Tests Results

Outcome	Including Default Cases		Excluding Default Cases	
	No.	Percent	No.	Percent
Pass (<i>dtect</i> occupancy = known occupancy, including SOV)	77	14 %	18	4 %
Fail - Undercount (<i>dtect</i> occupancy less than known occupancy)	466	84 %	466	95 %
Fail - Overcount (<i>dtect</i> occupancy more than known occupancy)	3	1 %	3	0 %
Missing (<i>dtect</i> image not found)	6	1 %	6	1 %
TOTAL	552	100 %	493	100%
